# **Noise Disturbance along Highways**

**Appendix: Section 2  
Traffic noise propagation  
through montane rainforest**

## Appendix 2.1 – 2005 Noise Transect Profiles

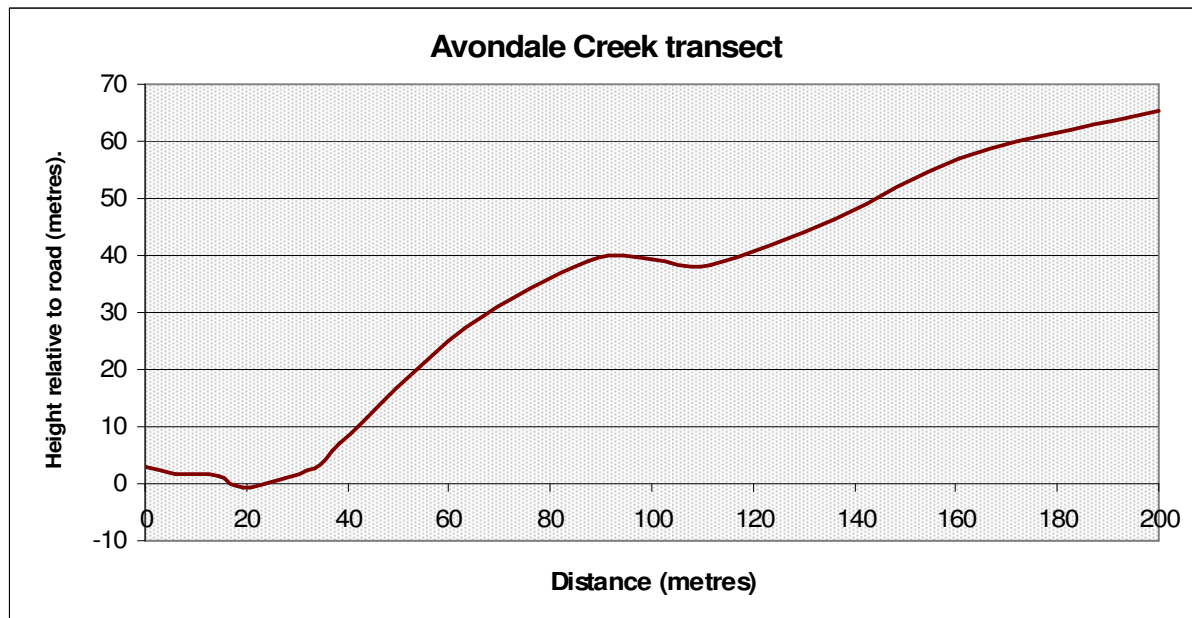
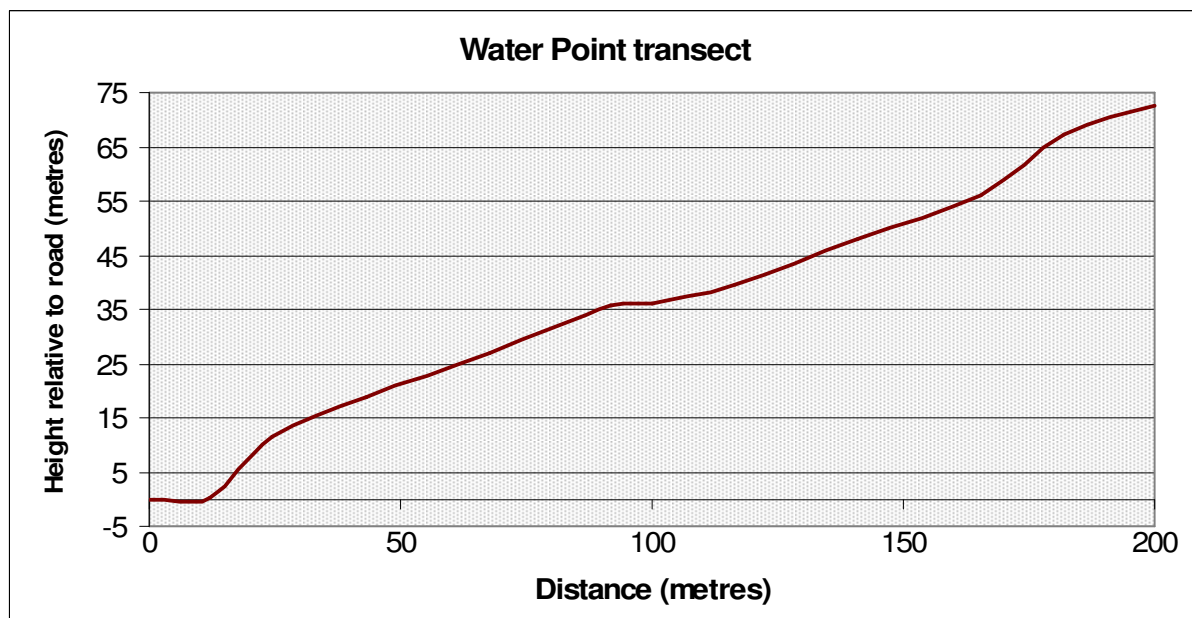
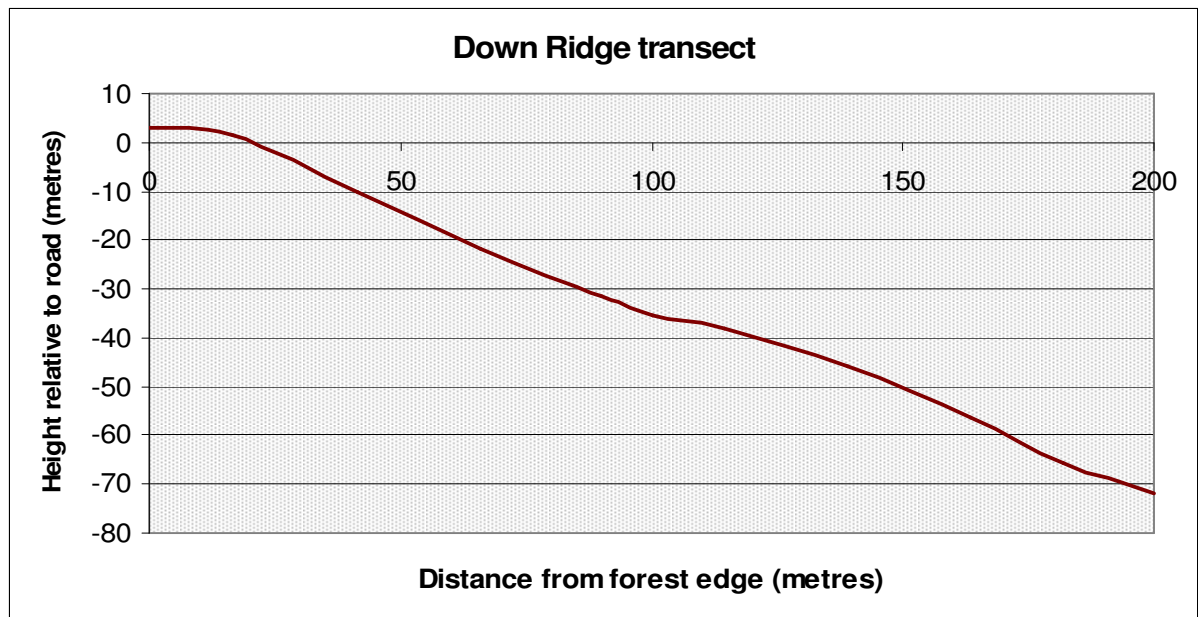
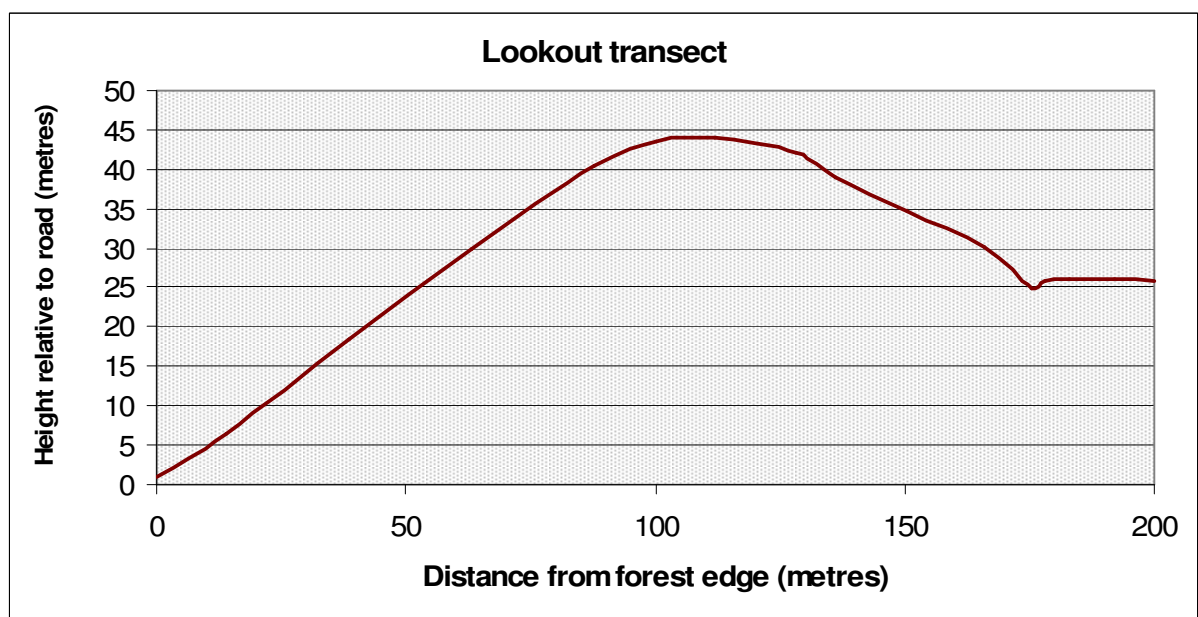
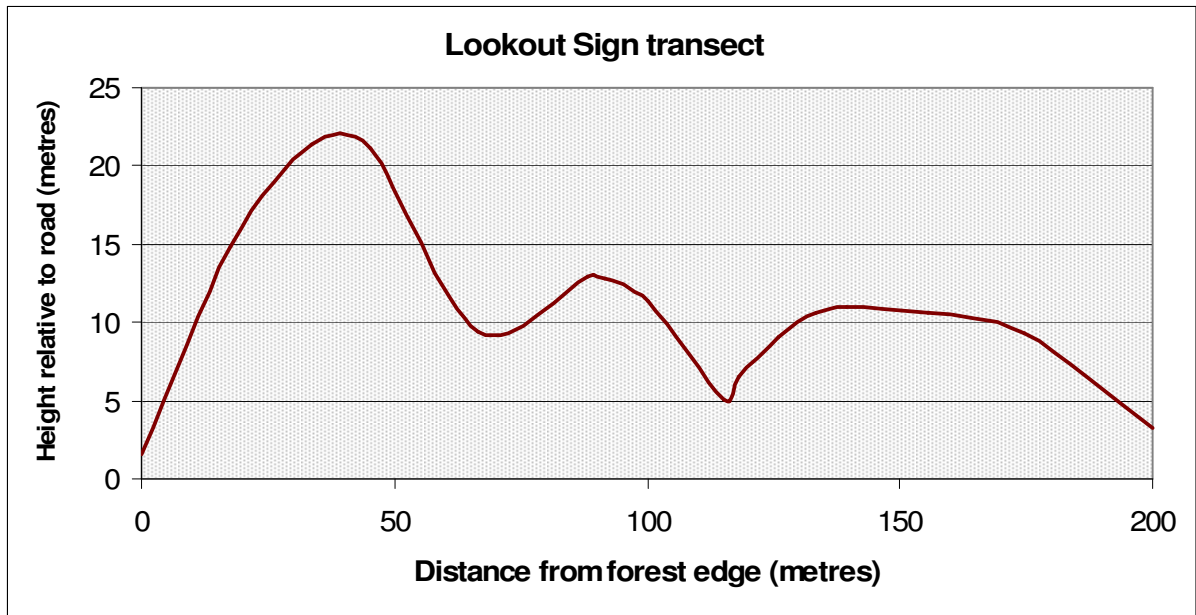
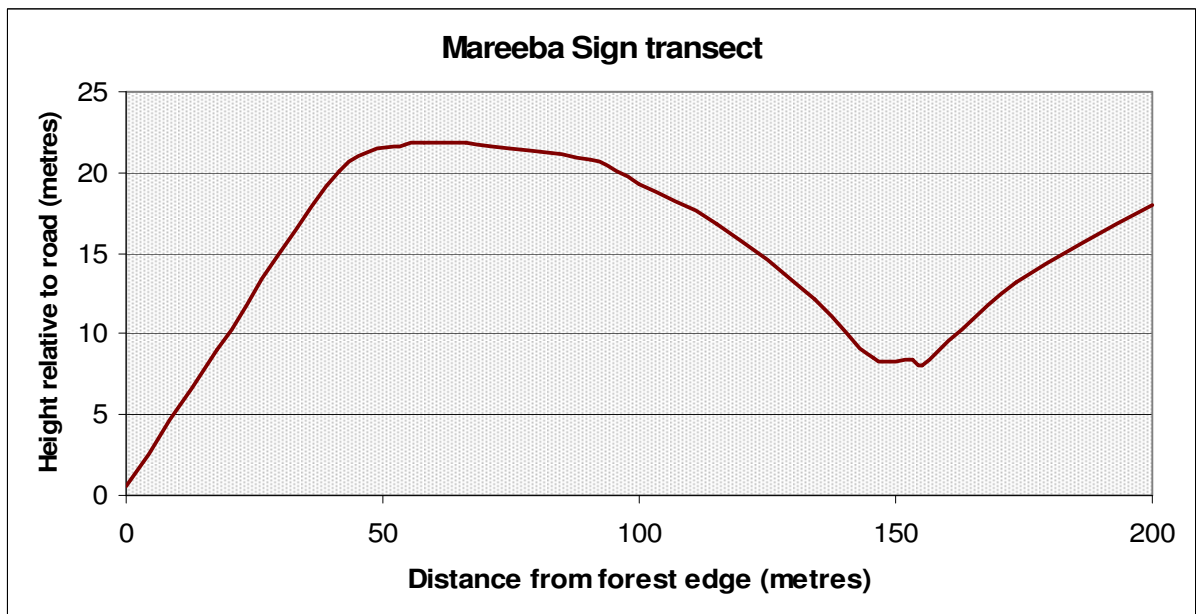
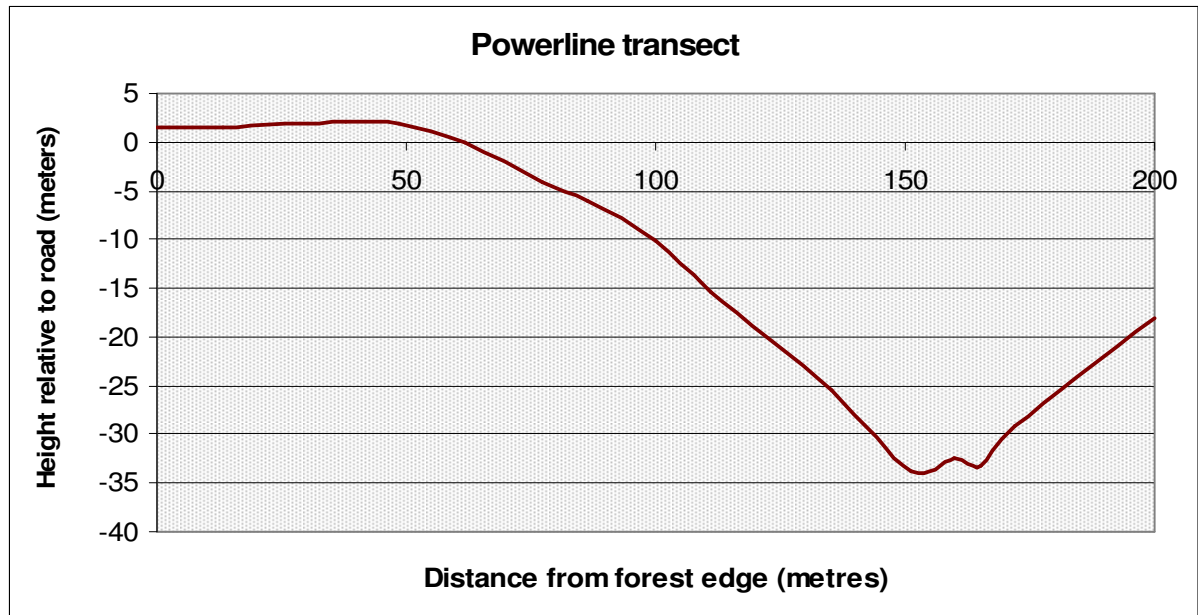
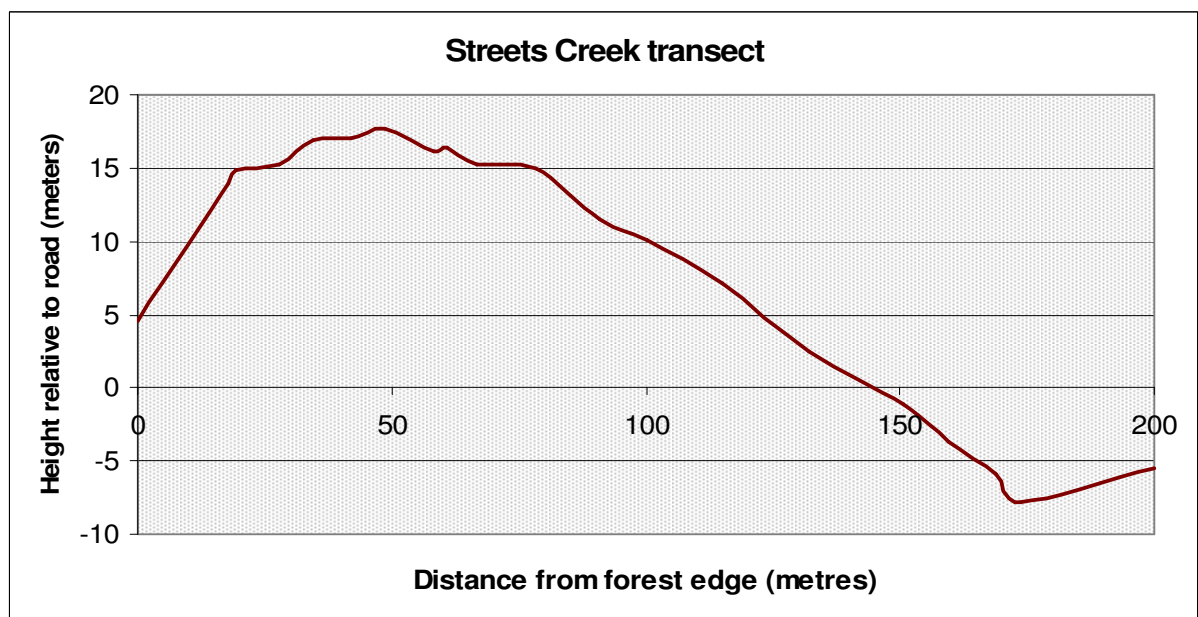
Heights and distances are taken from QDMR contour maps and profiles data, adjusted to local site data obtained using trigonometrical calculations from levels and distances obtained by hip-chain, laser rangefinders and GPS during pedestrian surveys of the sites.

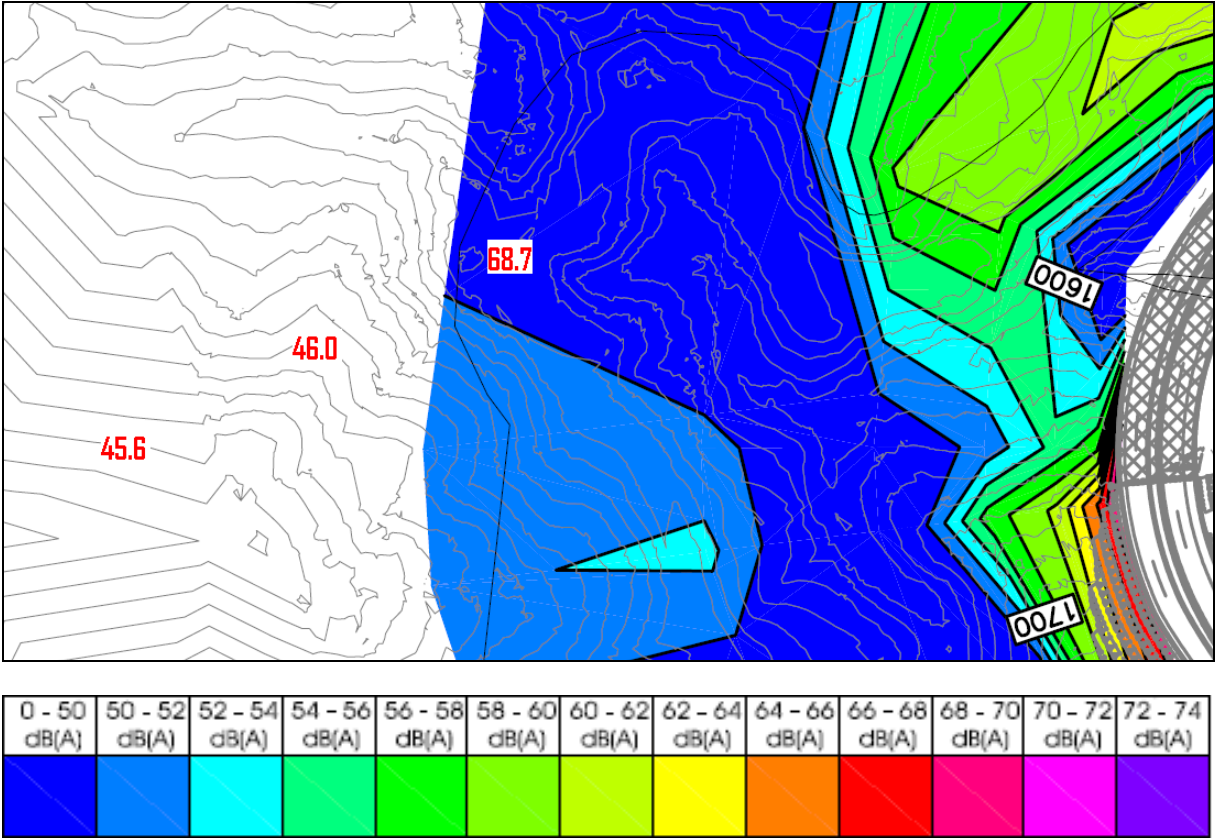
**Figure A2.2.1:** Avondale Creek transect  $L_{10}$  current and predicted noise levels at one metre above the forest floor (modified from ASK Consulting Engineers 2867FIGA, C6, 2006).

Modelling of ‘Ultimate’ predicted  $L_{10}$  ground noise levels for the upgraded Kuranda Range Road adjacent to sites of 2005 noise data collection (centre of inserts indicate ground noise levels from Rainforest CRC 2005 field recordings). All maps are displayed ‘north up’. Transect traverse distances are two hundred metres.

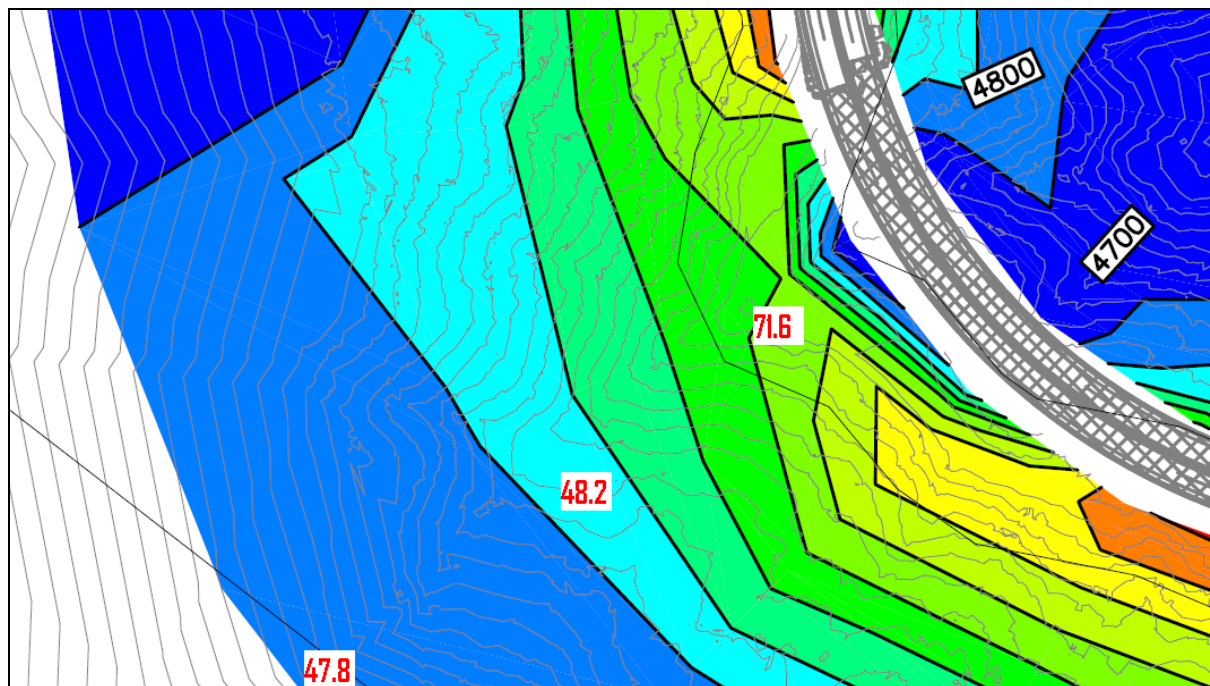
**Figure A2.2.2:** Water Point transect  $L_{10}$  current and predicted noise levels at one metre above the forest floor (modified from ASK Consulting Engineers 2867FIGA, C6, 2006).

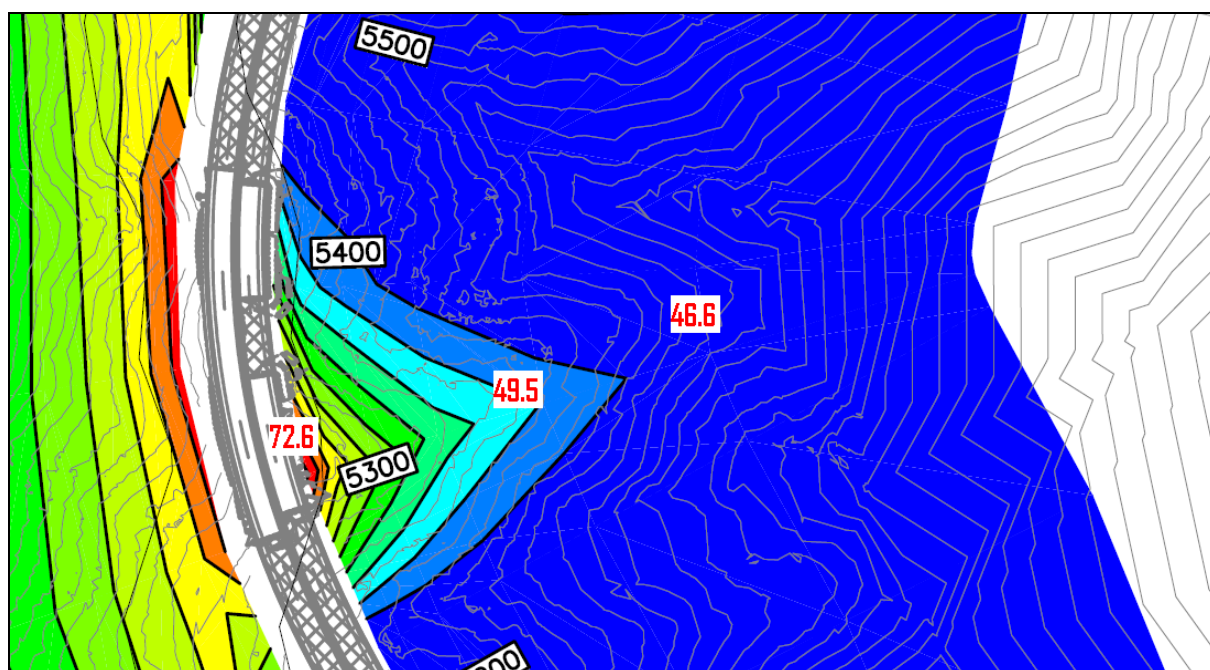
**Figure A2.2.3:** Down Ridge transect  $L_{10}$  current and predicted noise levels at one metre above the forest floor (modified from ASK Consulting Engineers 2867FIGA, C6, 2006).

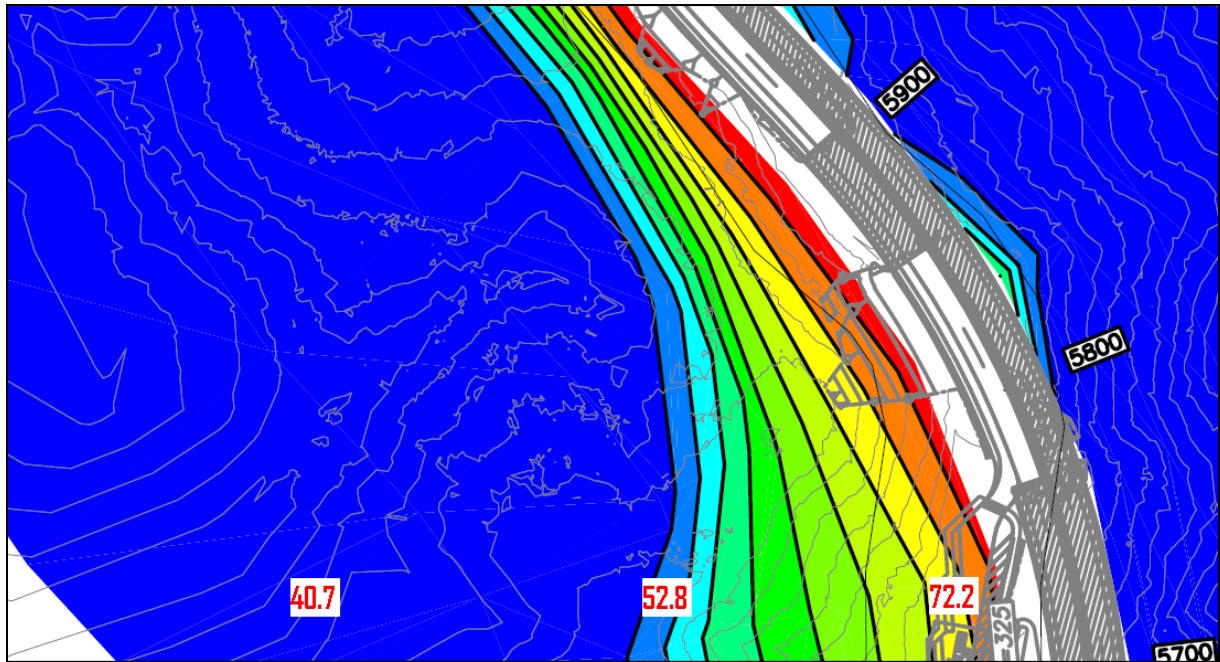
**Figure A2.2.4:** Lookout transect  $L_{10}$  current and predicted noise levels at one metre above the forest floor (modified from ASK Consulting Engineers 2867FIGA, C6, 2006).

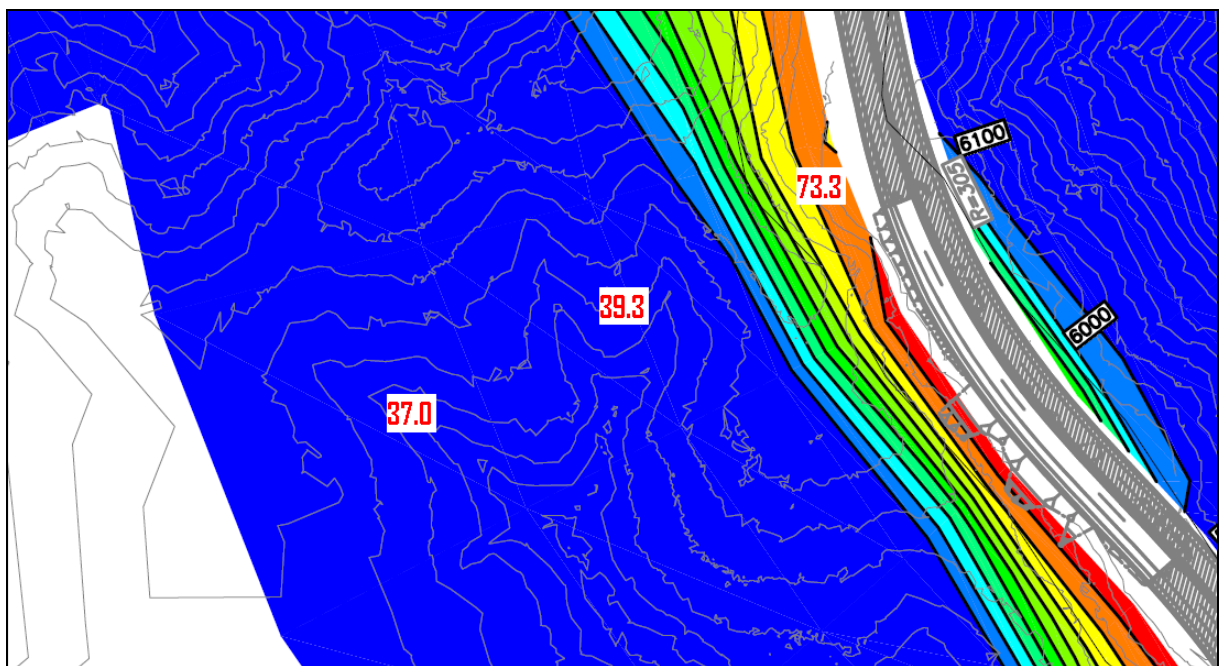
**Figure A2.2.5:** Lookout Sign transect  $L_{10}$  current and predicted noise levels at one metre above the forest floor (modified from ASK Consulting Engineers 2867FIGA, C6, 2006).

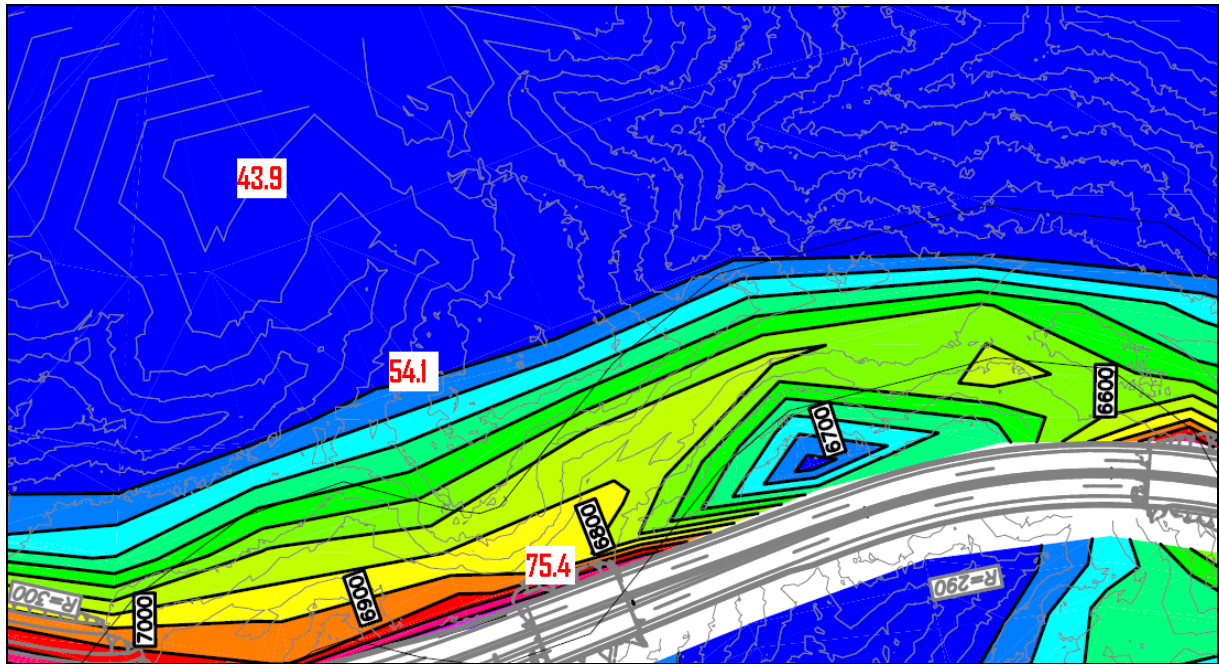
**Figure A2.2.6:** Mareeba Sign transect L<sub>10</sub> current and predicted noise levels at one metre above the forest floor (modified from ASK Consulting Engineers 2867FIGA, C6, 2006).

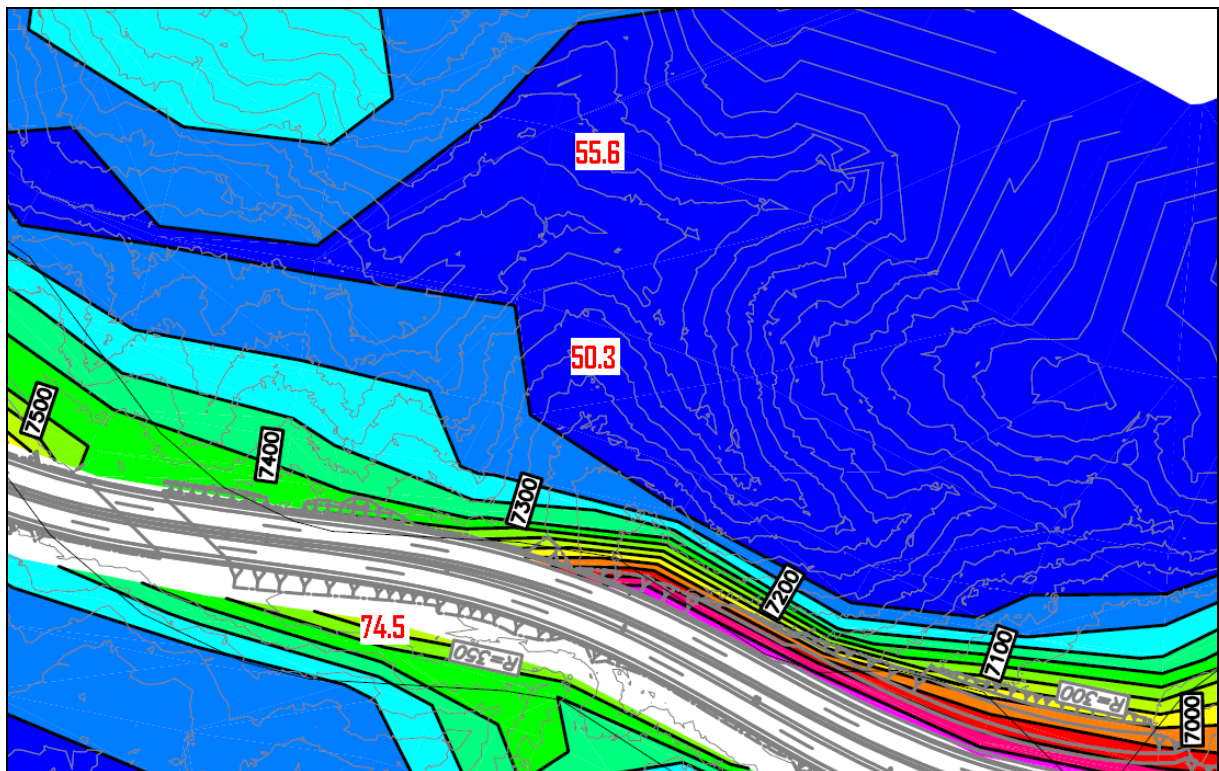
**Figure A2.2.7:** Powerline transect L<sub>10</sub> current and predicted noise levels at one metre above the forest floor (modified from ASK Consulting Engineers 2867FIGA, C6, 2006). Edge recordings undertaken at opposite side of existing road from transect start to eliminate risk posed by high voltage hazard during canopy recordings.

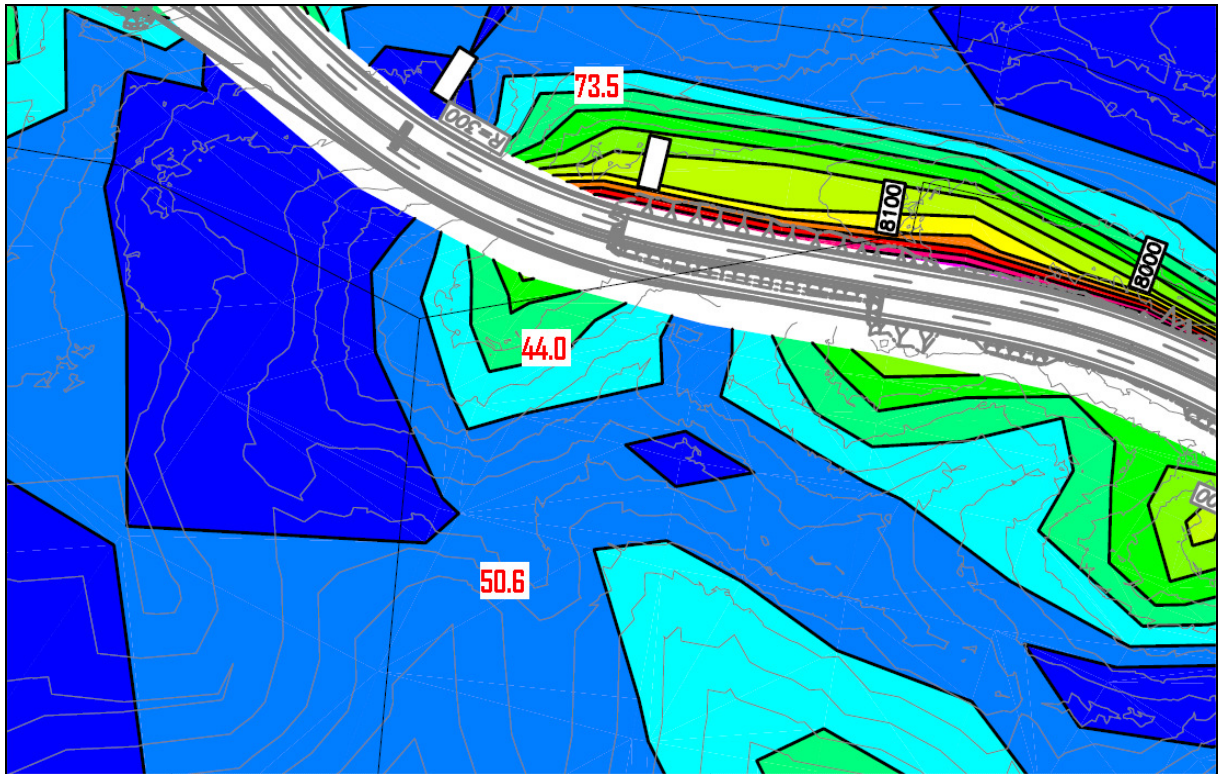
**Figure A2.2.8:** Streets Creek transect  $L_{10}$  current and predicted noise levels at one metre above the forest floor (modified from ASK Consulting Engineers 2867FIGA, C6, 2006).

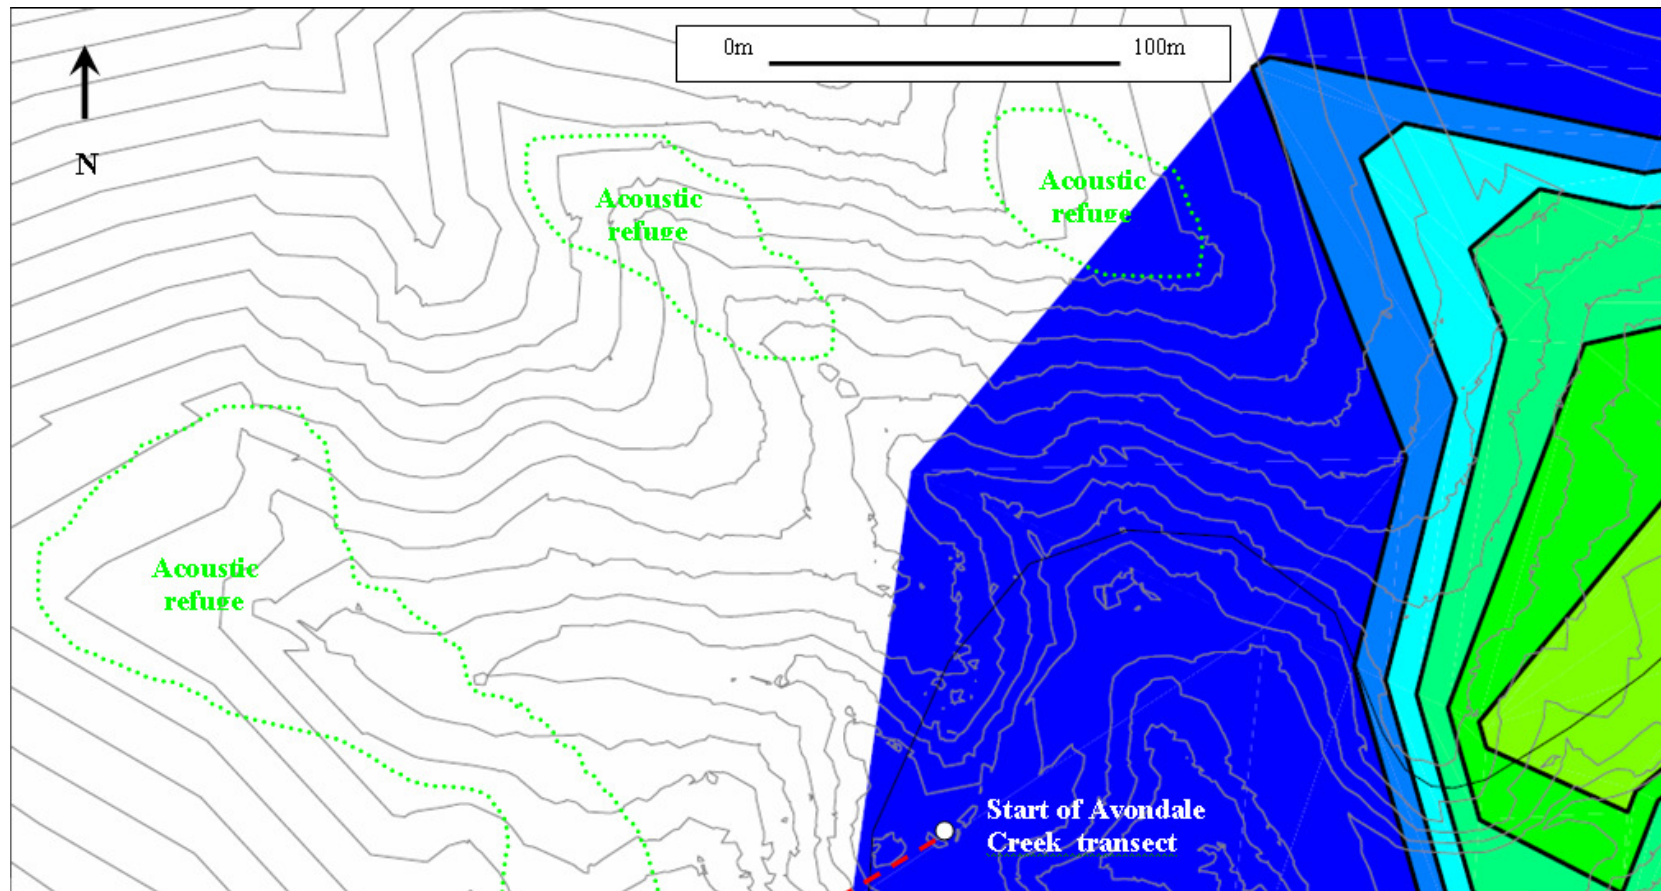
**Figure A2.3.1:** Acoustic refugia north of Avondale Creek transect (modified from ASK Consulting Engineers 2867FIGA, C11, 2003).

Potential locations of existing acoustic refugia and predicted 'Ultimate' ground  $L_{10}$  noise levels along the upgraded Kuranda Range Road (refugia boundary indicated by dotted green line).

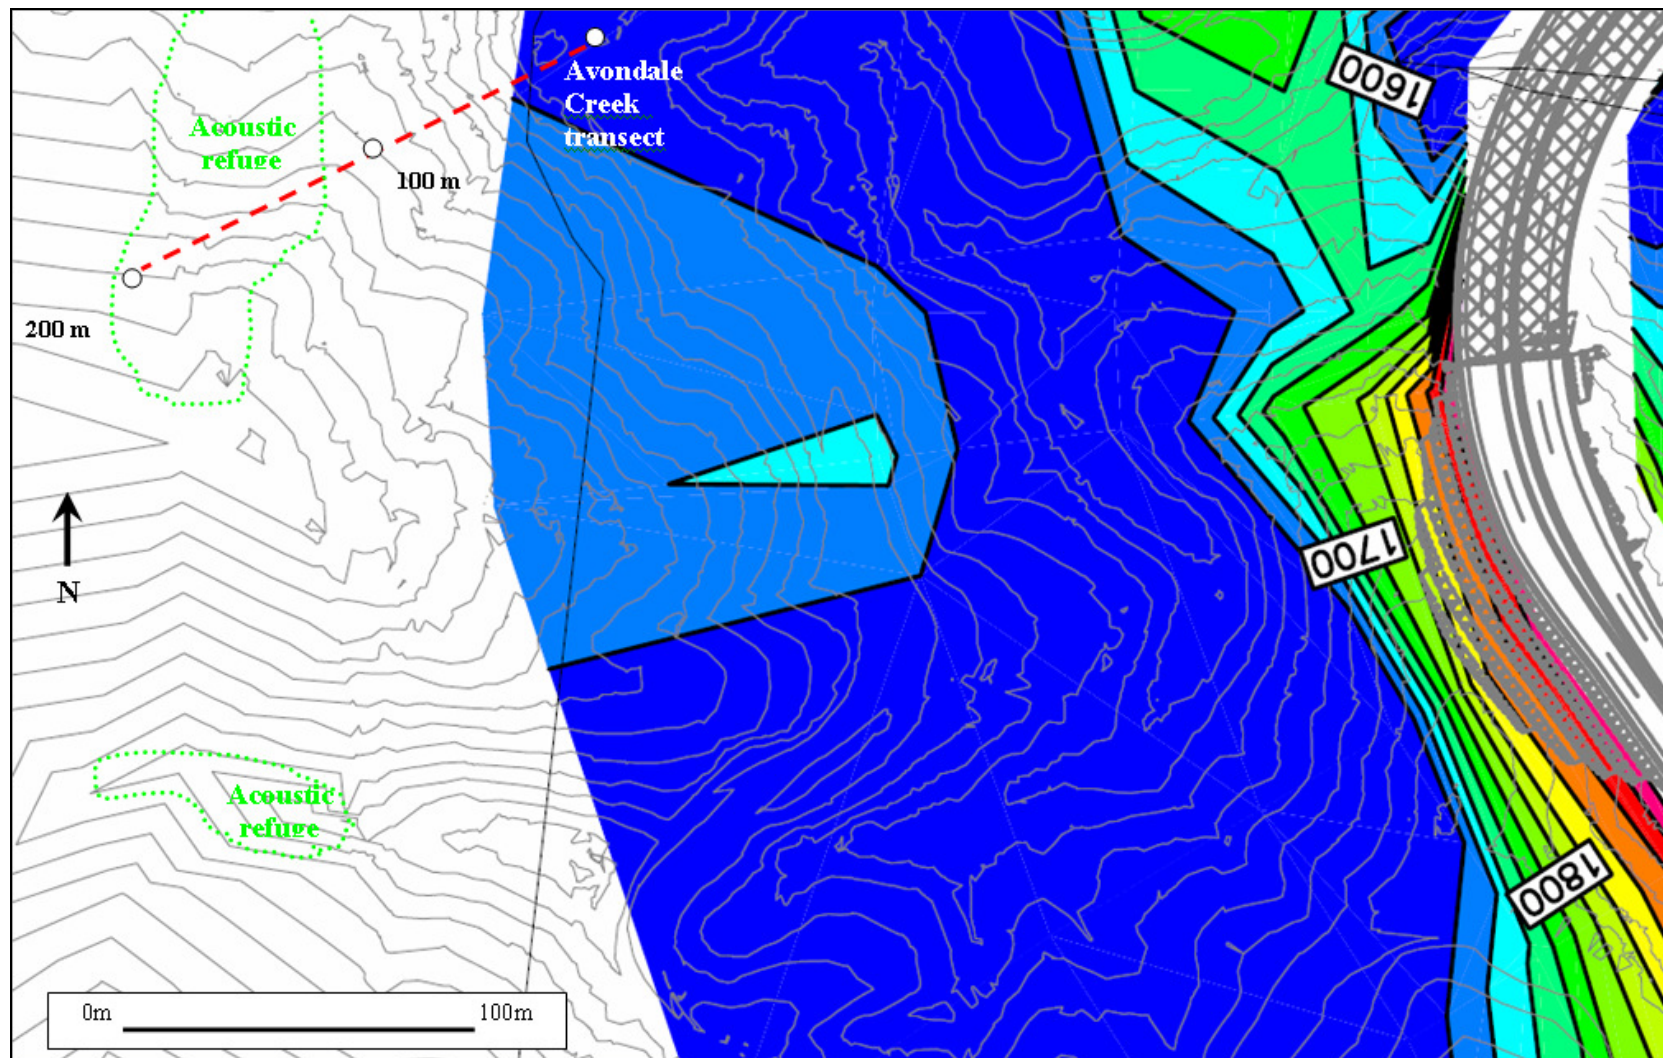
**Figure A2.3.2:** Acoustic refugia proximate to Avondale Creek transect (modified from ASK Consulting Engineers 2867FIGA, C11, 2003).

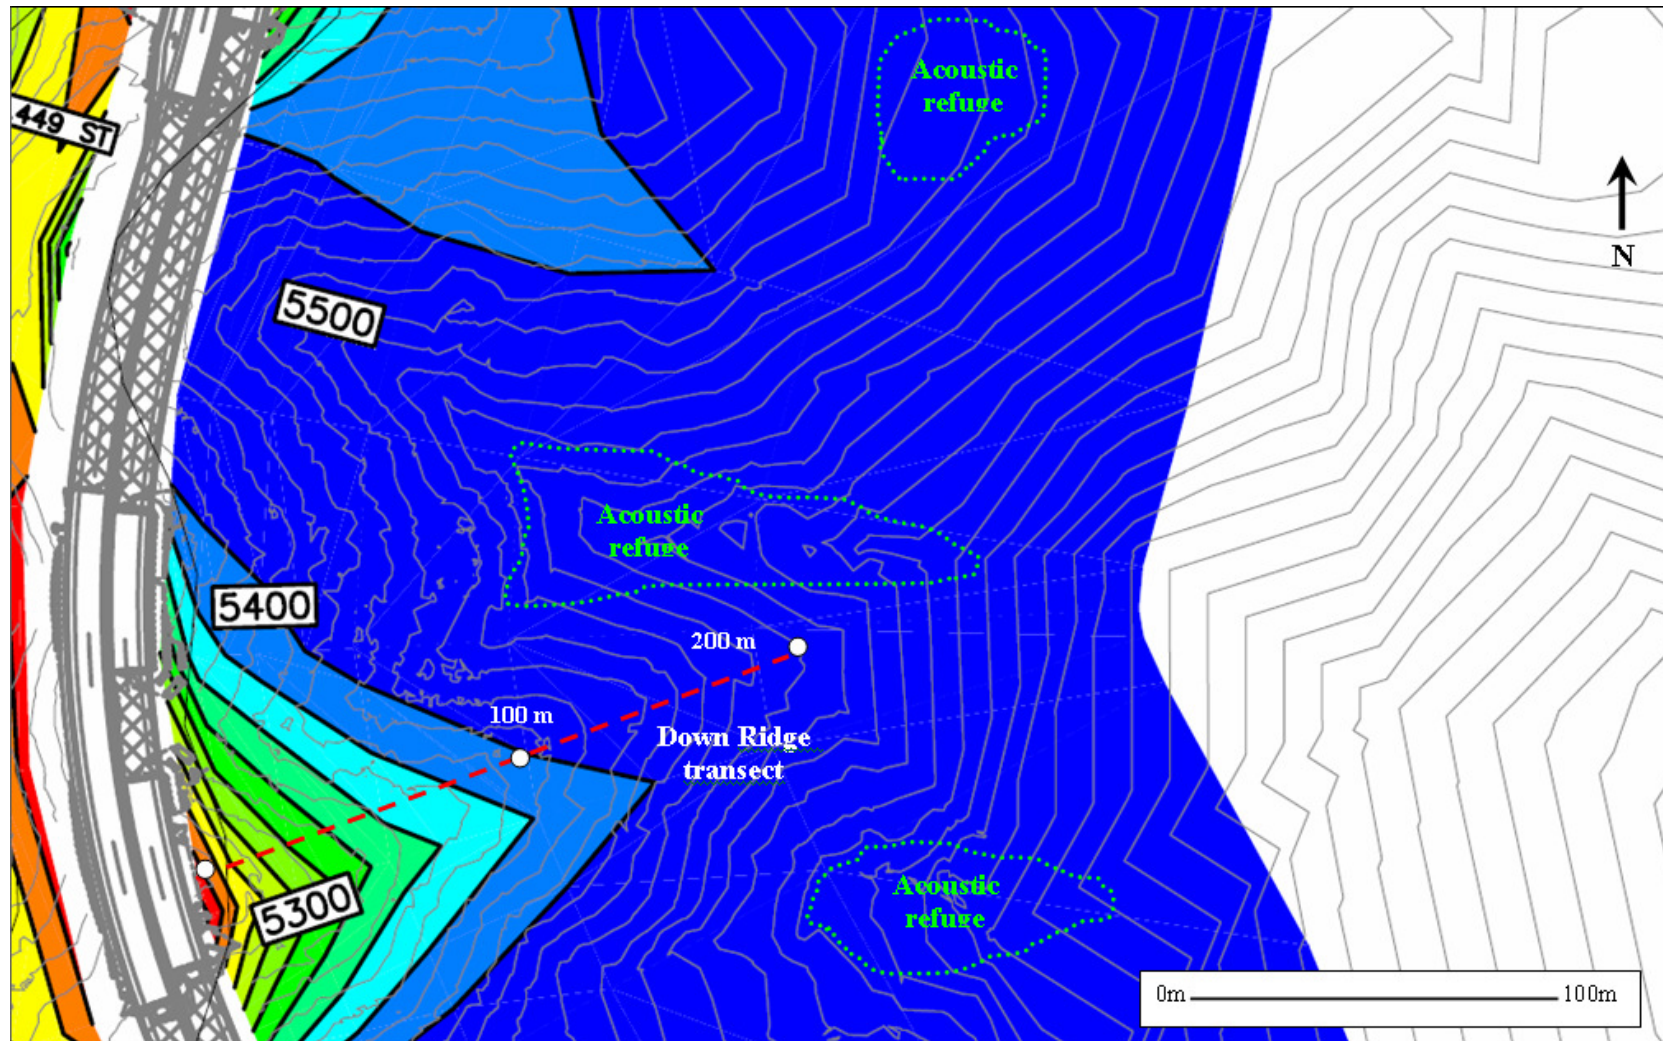
**Figure A2.3.3:** Acoustic refugia proximate to Down Ridge transect (modified from ASK Consulting Engineers 2867FIGA, C8, 2003).

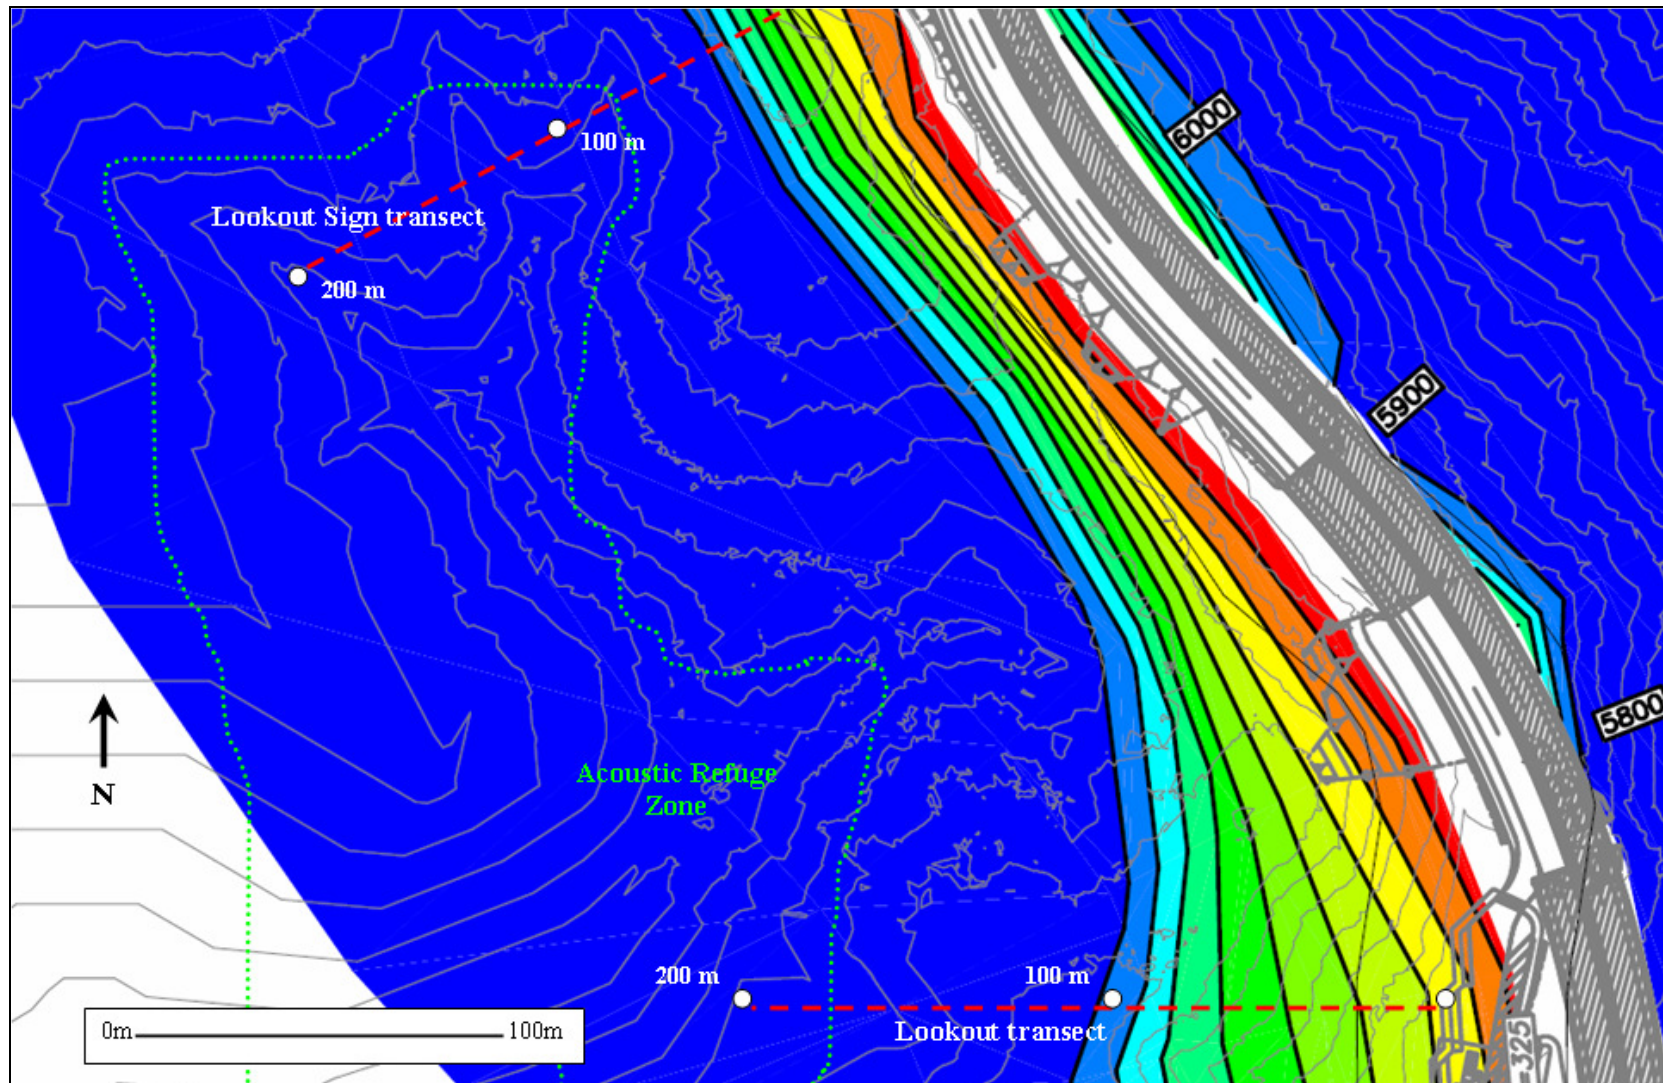
**Figure A2.3.4:** Acoustic refugia between Lookout and Lookout Sign transects (modified from ASK Consulting Engineers 2867FIGA, C7, 2003).

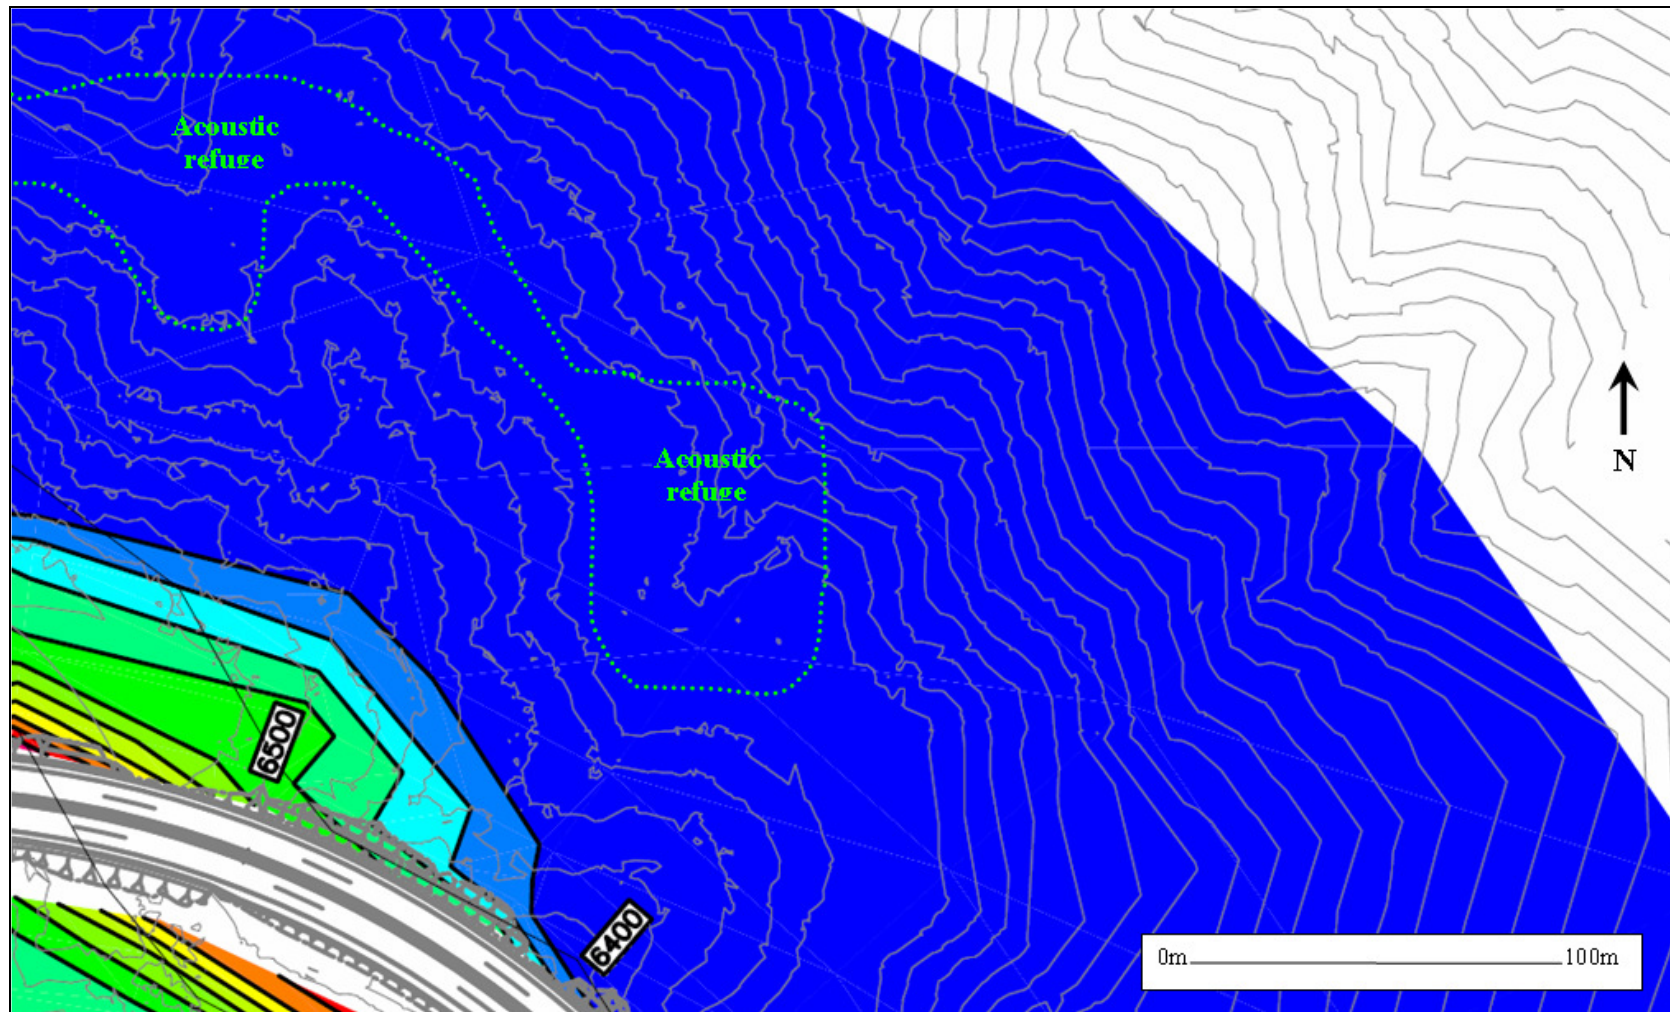
**Figure A2.3.5:** Acoustic refugia adjacent to Kuranda Range Road, north-south Ridge crossing (modified from ASK Consulting Engineers 2867FIGA, C6, 2003).
